Inspection Report

XXXX Street Drive
Parker CO 80134

Date: 10/10/2016	Time: 12:00 PM	Report ID: Sample Report
Property: XXXX Street Drive Parker CO 80134	Customer: Customer Name	Real Estate Professional:

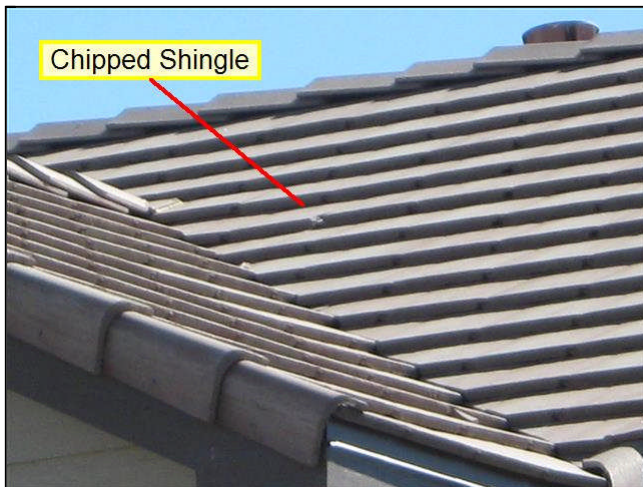
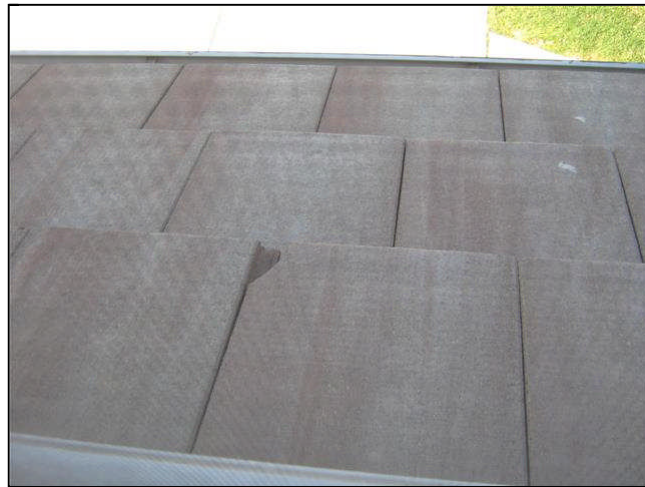
1.0 Item 1(Picture)

1.0 The roof covering is a concrete tile product, which has a long life expectancy if properly maintained. It is in generally good conditions. There are a couple of chipped shingles that need to be repaired. One is on the 2nd level northwest area and the other is the roof above the 2 door garage. The 2nd level south side of the roof was not visible. However, the attic space below this part of the roof was accessible and there are no sign of leaks. Recommend having a roofing company inspect and make repairs as necessary.

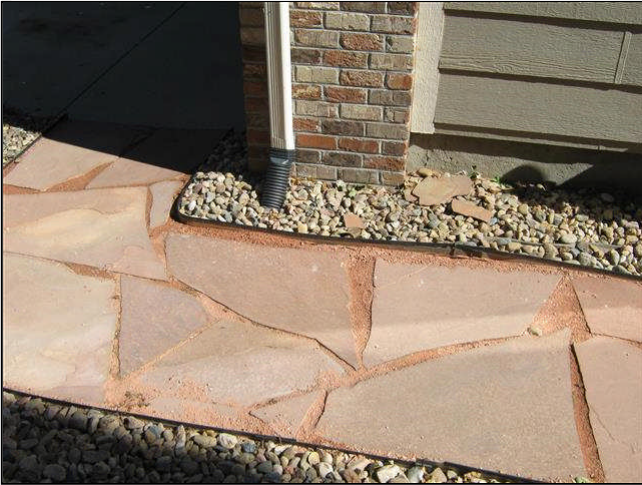
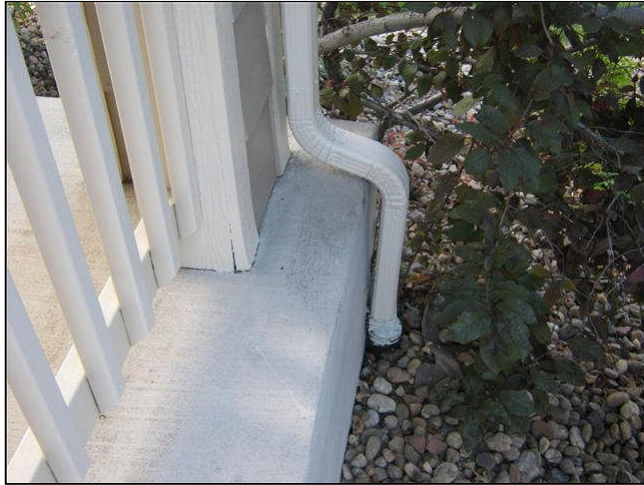
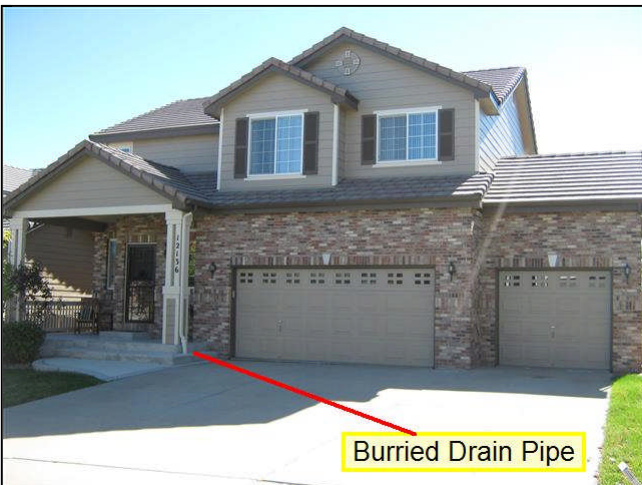
1.1 Item 1(Picture) West Side of Garage

1.1 Downspouts by the front porch and on the northwest corner discharge into buried drain pipes. Buried drain pipes can cause settling problems when they are clogged. There has been settling on the driveway, and the front porch has been replaced with new concrete. I cannot find where the gutter drains daylight or determine if they function correctly. They should daylight and discharge on the surface at least 10 feet away from the house. I suspect that they are clogged because of the settling. They should be checked for clogs and leaks by a sewer scope pipe inspector. Repair or replace with surface gutter extenders that discharge at least 5 feet from the house.

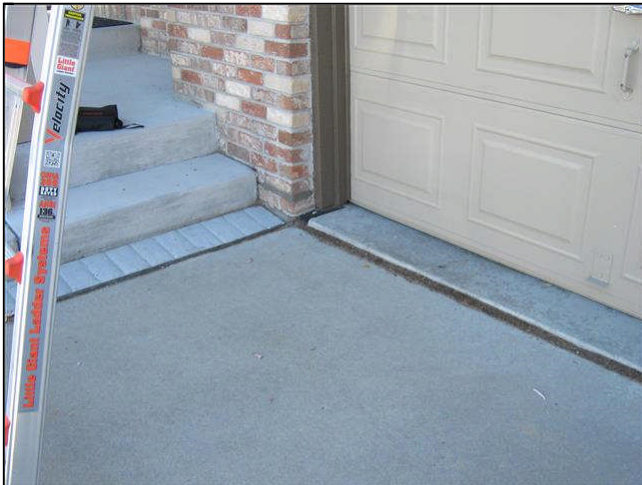
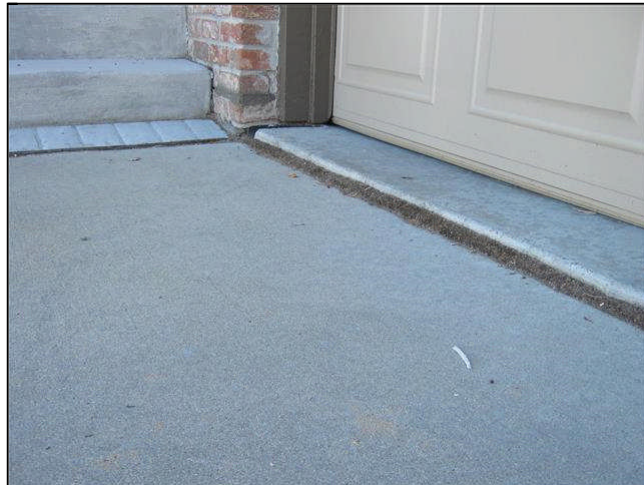
2.2 Item 1(Picture)

2.2 (1) The driveway in front of the garage door by the front porch has settled and is sloping back towards the front porch. The slab in front of the garage by the front porch needs to be replaced so that there is a minimum 1/8 inch per foot slope away from the porch and the garage.

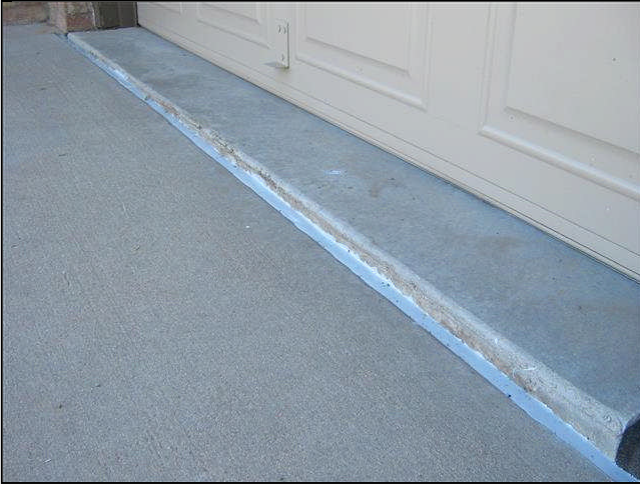
2.2 Item 3(Picture)

(2) The driveway in front of the west garage door has settled. Much of the driveway has settled to some degree. Cracks are present along the control joists throughout the driveway. Settling may be from buried drain pipes being clogged now or in the past (see item 1.1). Inquire with sellers.

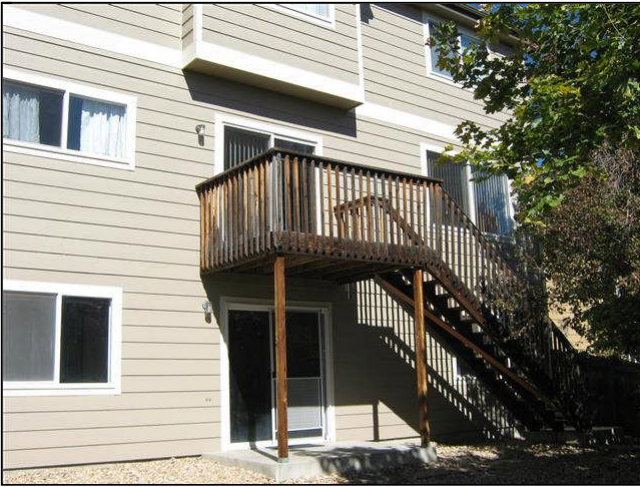
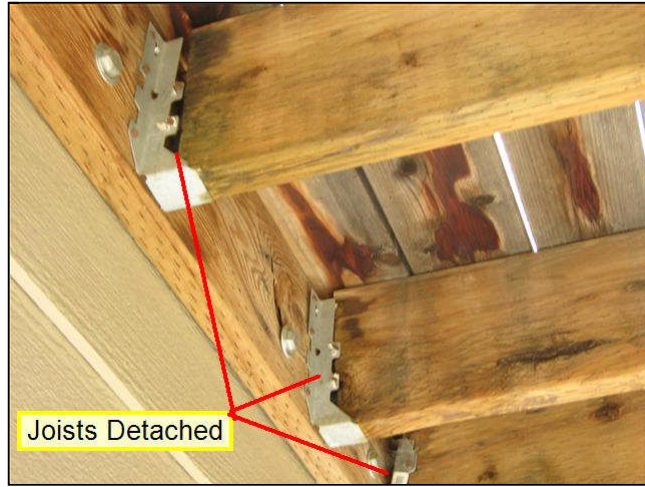
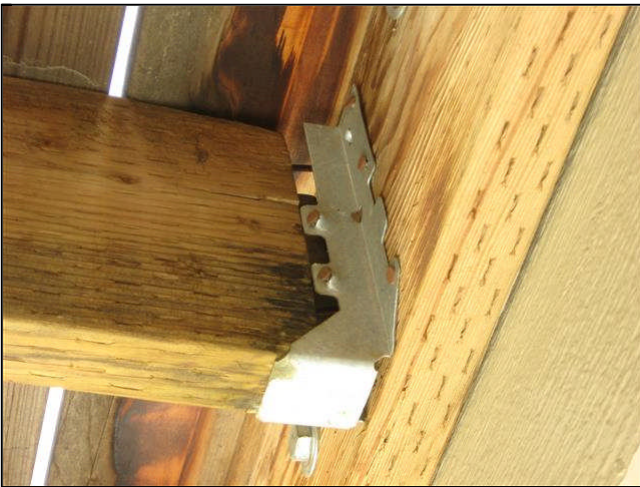
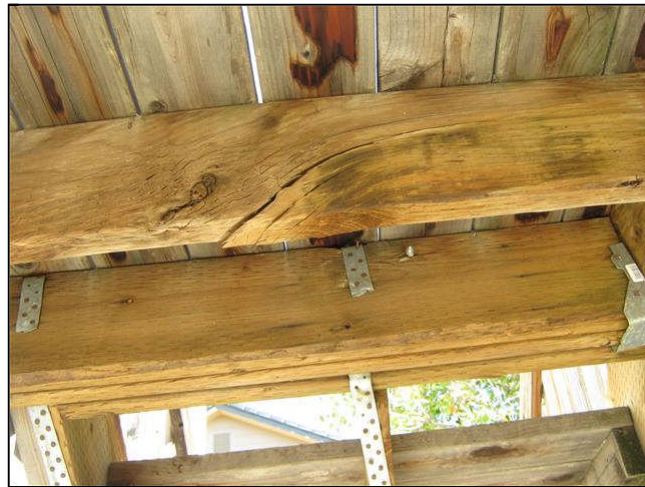
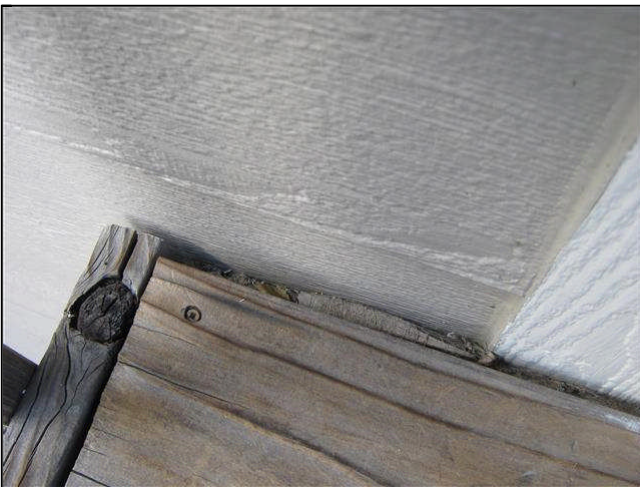
2.4 Item 1(Picture)

2.4 SAFETY HAZARD: Deck may not be structurally sound. Deck joists are detached from the joist hangers mounted to the ledger. One joist is cracked. Steel hardware is becoming detached in several places. The posts need to be cross braced. One of the posts is twisted from drying. Flashing is missing over the ledger. The decking surface is in poor condition. The handrail for the stairs is not properly attached and is loose. The deck needs to be rebuilt by a licensed contractor.

2.4 Item 4(Picture) Cracked Joist

2.4 Item 5(Picture) Missing Flashing

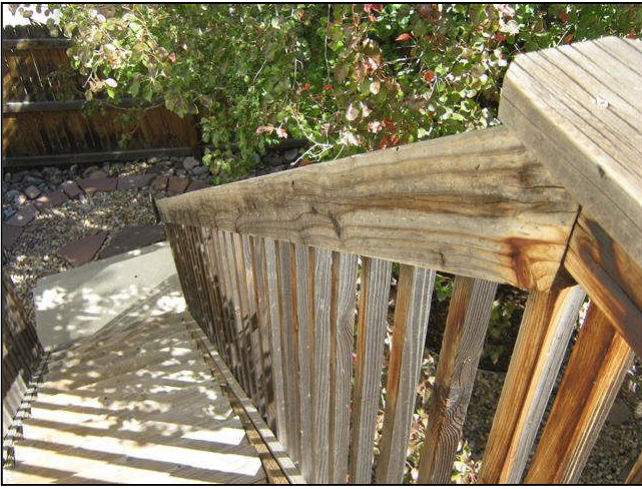
2.5 Item 1(Picture)

2.5 SAFETY HAZARD: Handrail for the deck stairway is loose (see item 2.4).

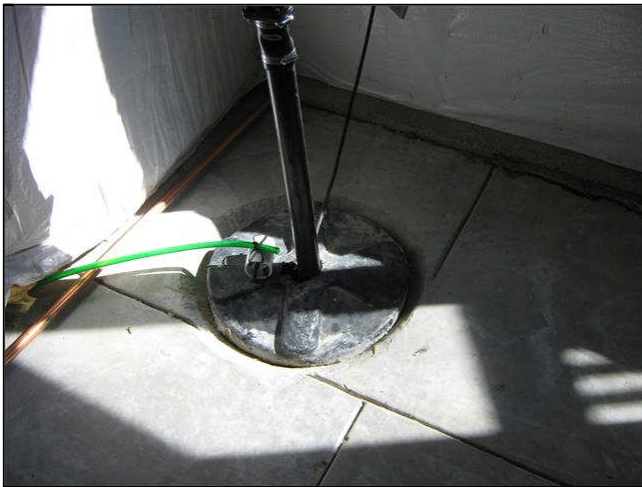
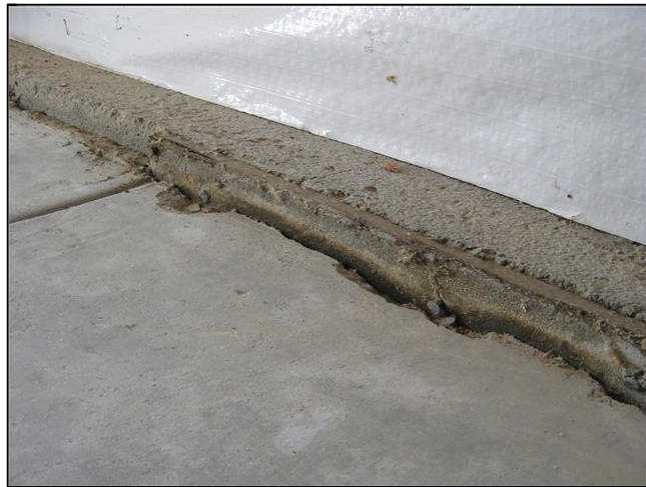
3.3 Item 1(Picture)

3.3 Moderate settling of the basement slab around the sump pit. Consult a "mud jacking" company. They may be able to push it back into it's original position or they may just be able to help stabilize the slab.

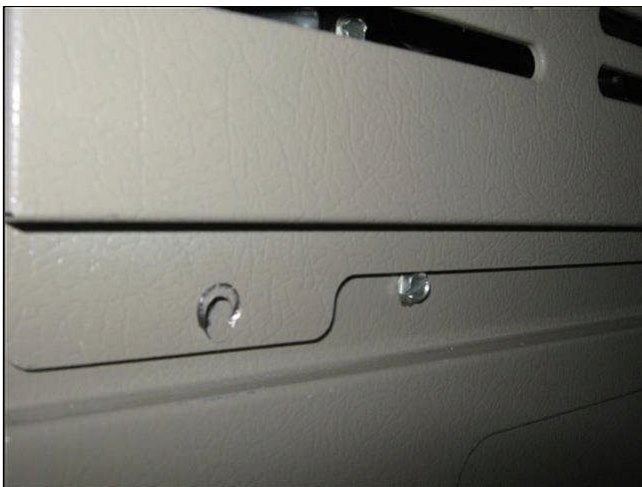
4.0 Item 1(Picture)

4.0 (1) There is a screw missing on the cover door for the furnace.

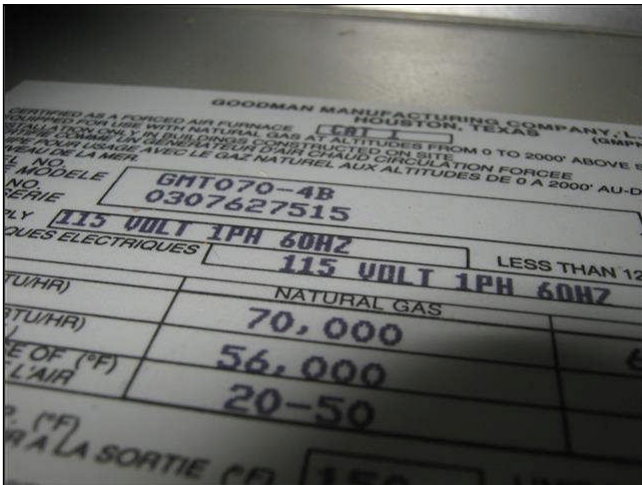
4.0 Item 2(Picture)

(2) The furnace is in good condition. It is clean, and has a filter installed. It appears to be well maintained. It is still recommended that you have a professional service the unit each year before the cold season begins.

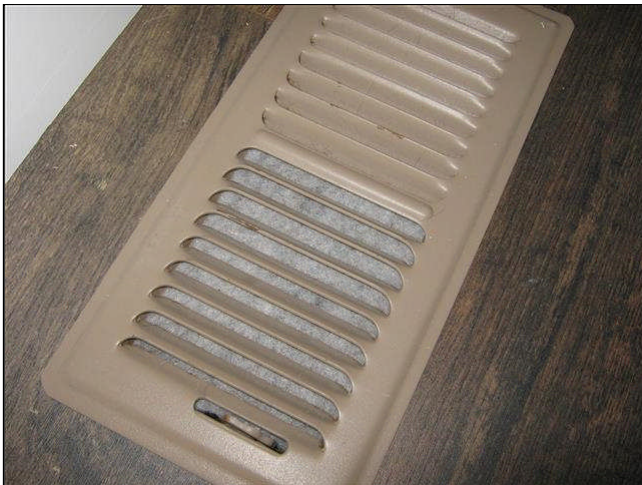
4.3 Item 1(Picture)

4.3 There is a filter in most of the registers. This is impeding air flow which could shorten the life span of the furnace. I recommend removing them.

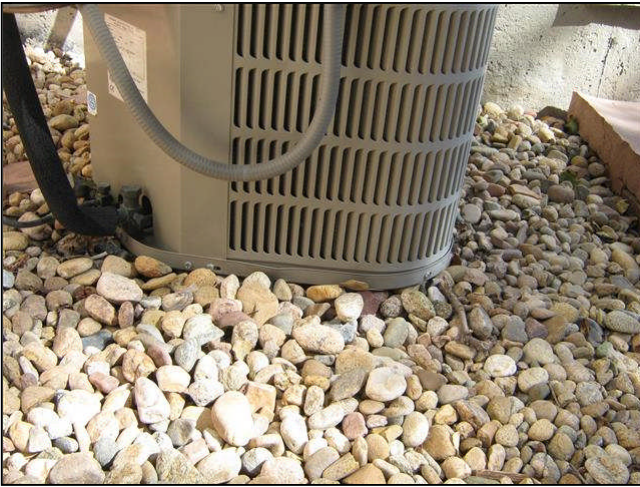
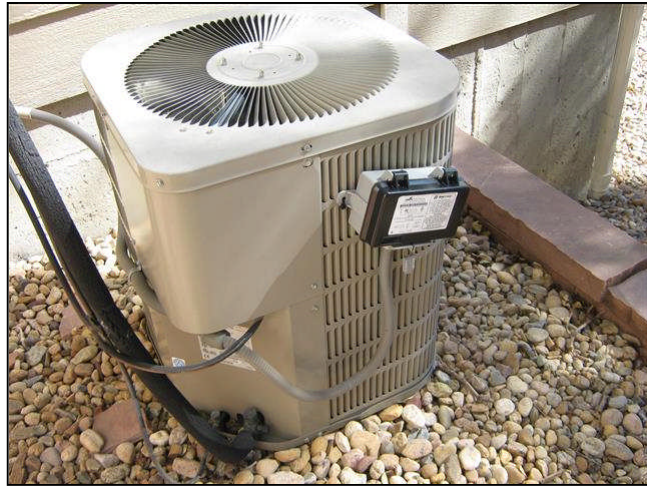
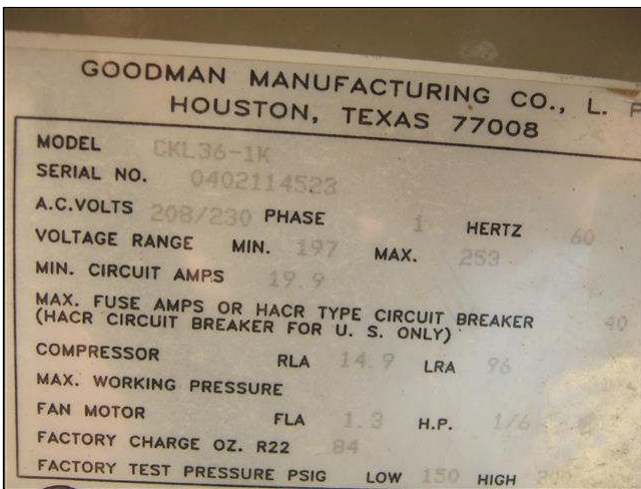
4.6 Item 1(Picture)

4.6 AC compressor is not on a concrete pad. Compressor needs to have a level concrete pad installed.

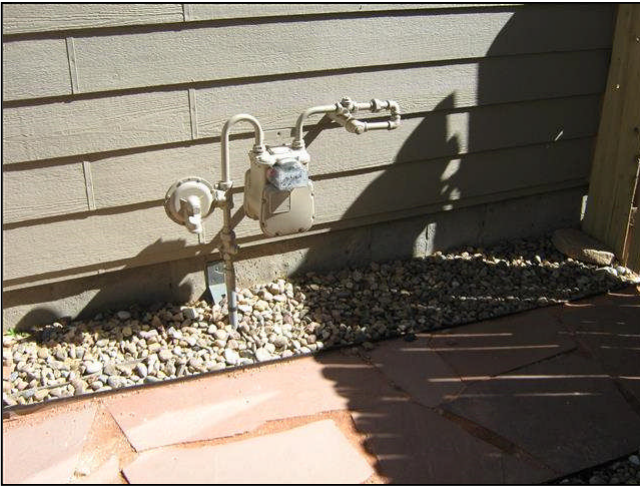
5.1 Item 1(Picture)

5.1 The main fuel shut off is at gas meter outside on the west side of the garage

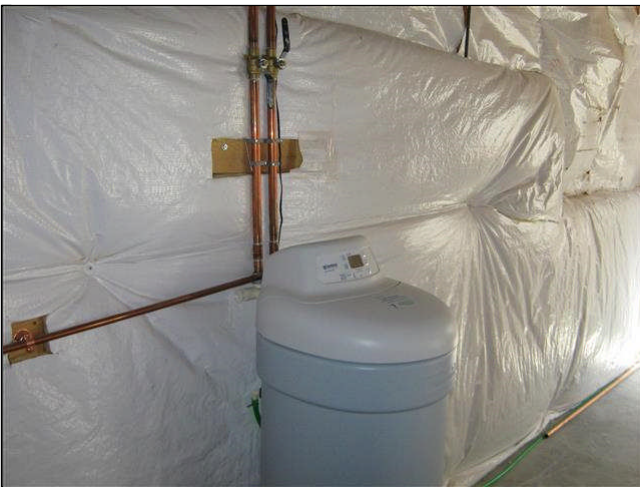
5.3 Item 1(Picture)

5.3 There is a water softener in the basement. I recommend consulting a water softener expert and having the unit serviced.

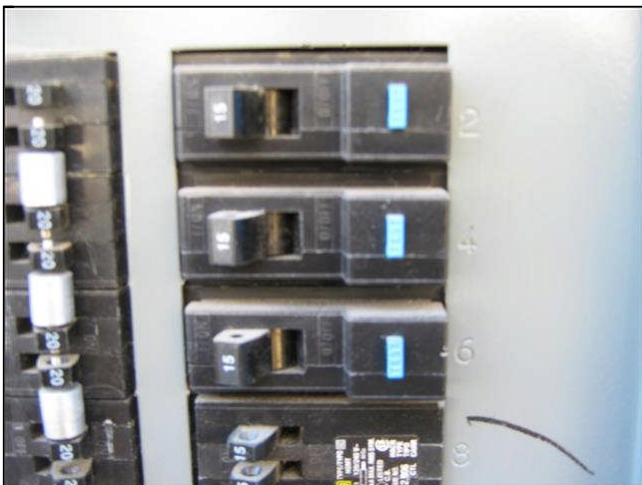
6.3 Item 1(Picture)

6.3 SAFETY HAZARD: The panel has 3 Square D manufactured AFCI breakers. Square D AFCI circuit breakers manufactured between March 1, 2004 and September 23, 2004 (Square D AFCI's with blue buttons) have been recalled. A licensed electrician is needed to check the date codes on these breakers to determine if they are subject to the recall. Consult a licensed electrician and replace if necessary.

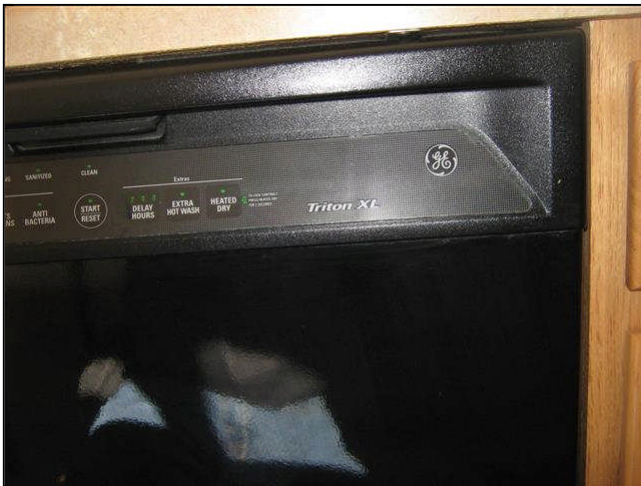
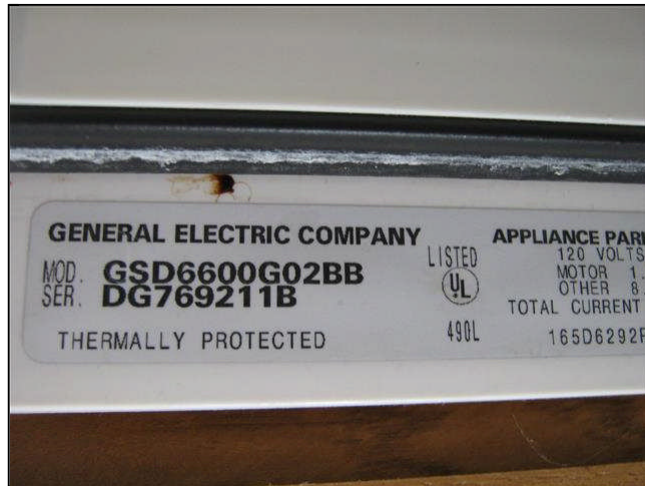
11.0 Item 1(Picture)

11.0 (1) Dishwasher is very noisy. It may need to be replaced soon.

(2) Dishwasher manufactured by GE in 2004, according to online source (Appliance 411).

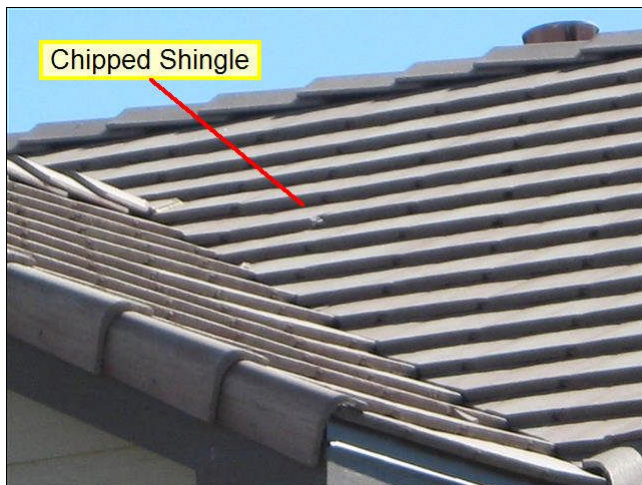
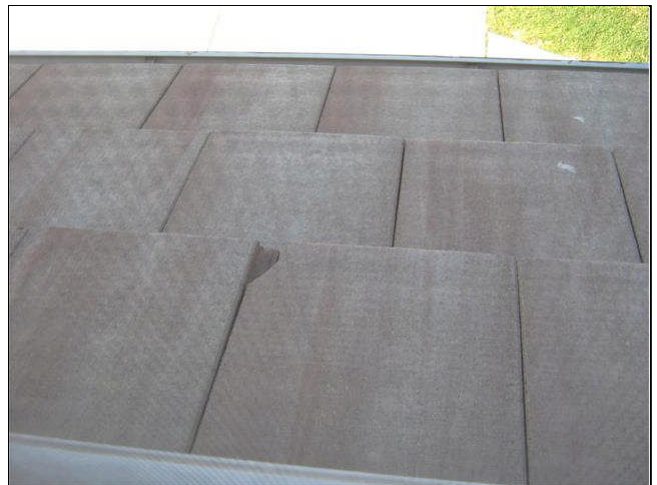
1.0 Item 1(Picture)

The roof covering is a concrete tile product, which has a long life expectancy if properly maintained. It is in generally good conditions. There are a couple of chipped shingles that need to be repaired. One is on the 2nd level northwest area and the other is the roof above the 2 door garage. The 2nd level south side of the roof was not visible. However, the attic space below this part of the roof was accessible and there are no sign of leaks. Recommend having a roofing company inspect and make repairs as necessary.

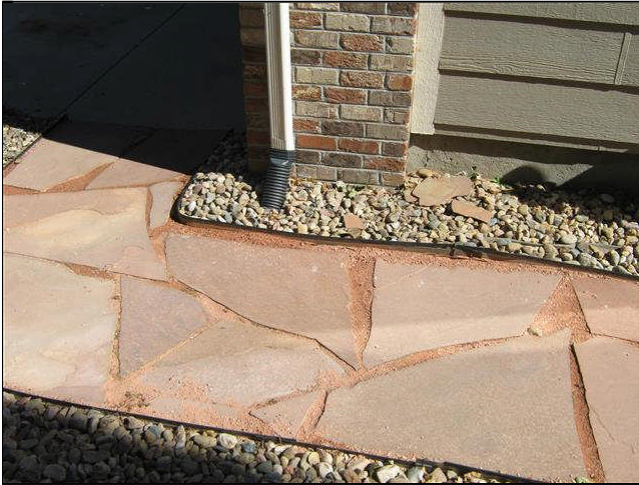
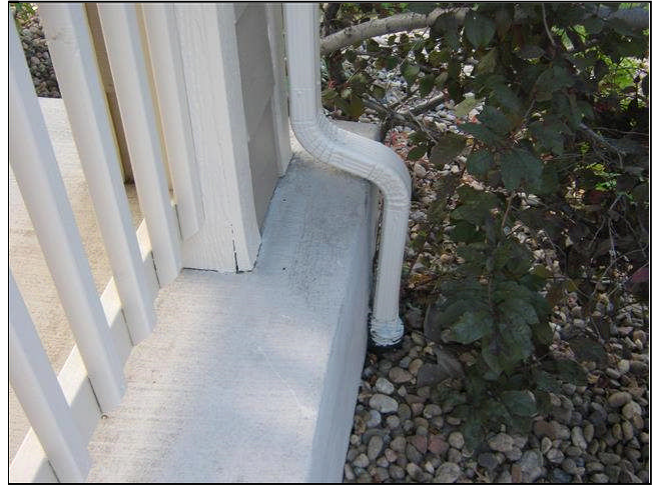
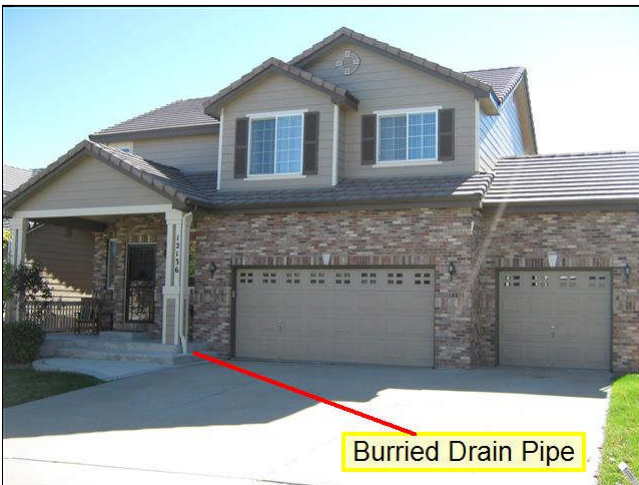
1.1 Item 1(Picture) West Side of Garage

Downspouts by the front porch and on the northwest corner discharge into buried drain pipes. Buried drain pipes can cause settling problems when they are clogged. There has been settling on the driveway, and the front porch has been replaced with new concrete. I cannot find where the gutter drains daylight or determine if they function correctly. They should daylight and discharge on the surface at least 10 feet away from the house. I suspect that they are clogged because of the settling. They should be checked for clogs and leaks by a sewer scope pipe inspector. Repair or replace with surface gutter extenders that discharge at least 5 feet from the house.

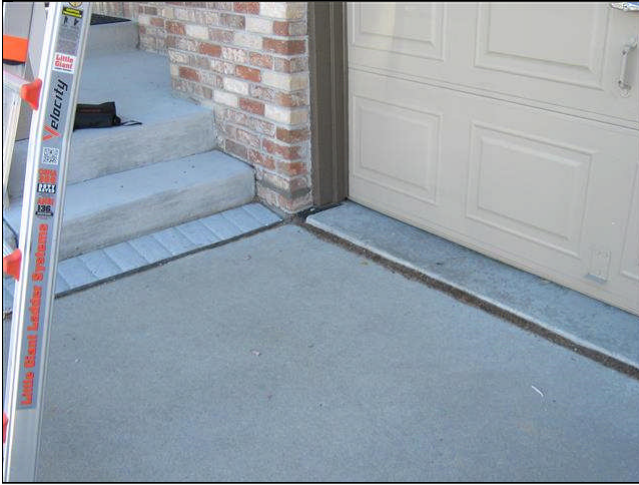
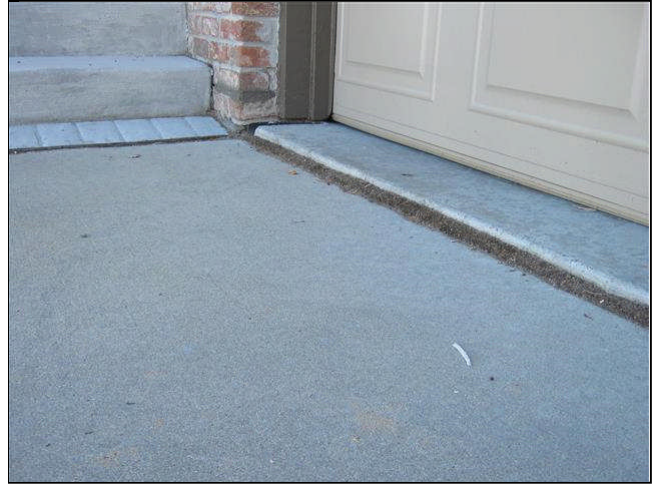
2.2 Item 1(Picture)

(1) The driveway in front of the garage door by the front porch has settled and is sloping back towards the front porch. The slab in front of the garage by the front porch needs to be replaced so that there is a minimum 1/8 inch per foot slope away from the porch and the garage.

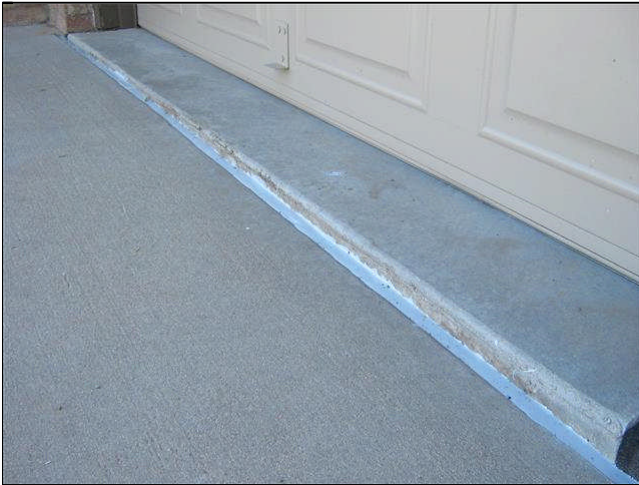
2.2 Item 3(Picture)

(2) The driveway in front of the west garage door has settled. Much of the driveway has settled to some degree. Cracks are present along the control joists throughout the driveway. Settling may be from buried drain pipes being clogged now or in the past (see item 1.1). Inquire with sellers.

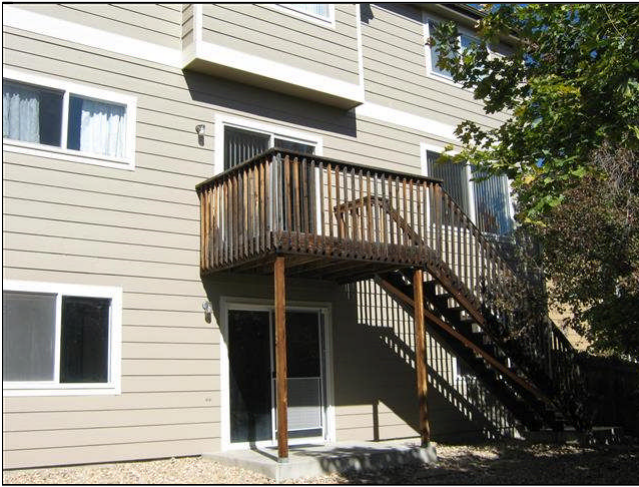
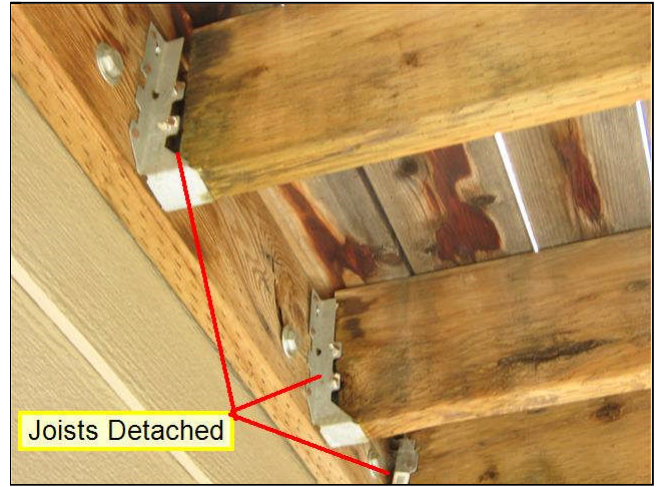
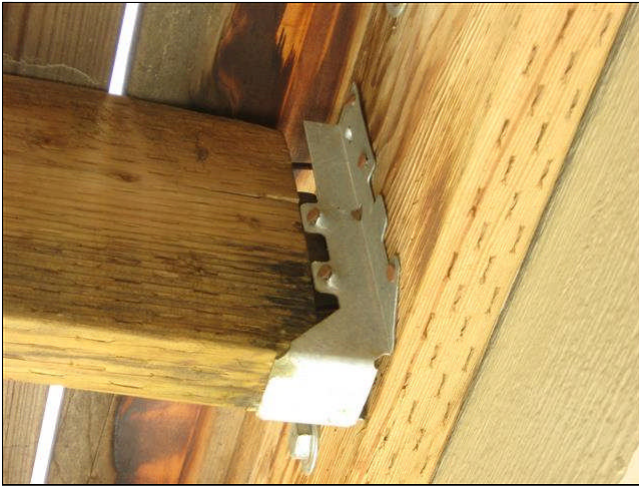
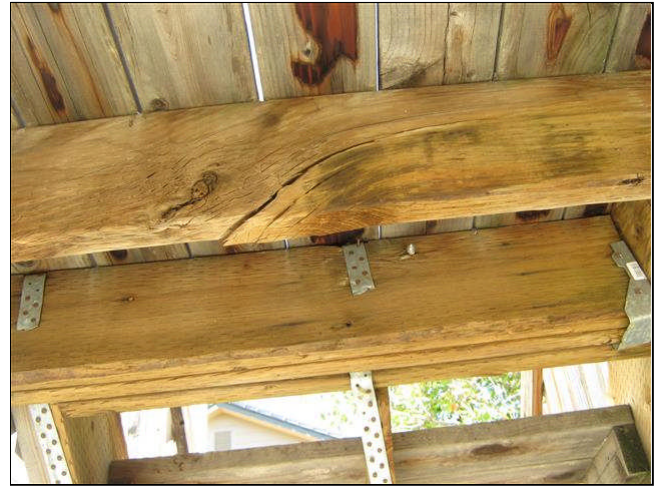
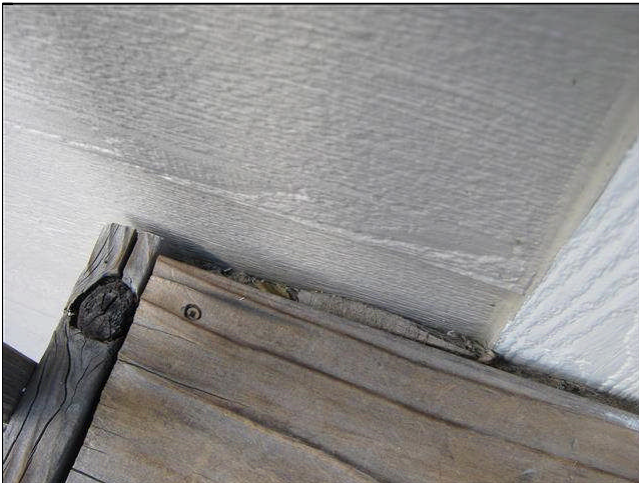
2.4 Item 1(Picture)

SAFETY HAZARD: Deck may not be structurally sound. Deck joists are detached from the joist hangers mounted to the ledger. One joist is cracked. Steel hardware is becoming detached in several places. The posts need to be cross braced. One of the posts is twisted from drying. Flashing is missing over the ledger. The decking surface is in poor condition. The handrail for the stairs is not properly attached and is loose. The deck needs to be rebuilt by a licensed contractor.

2.4 Item 4(Picture) Cracked Joist

2.4 Item 5(Picture) Missing Flashing

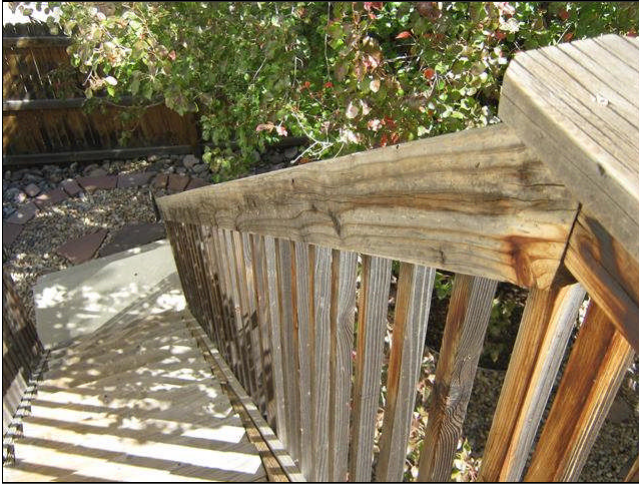
2.5 Item 1(Picture)

SAFETY HAZARD: Handrail for the deck stairway is loose (see item 2.4).

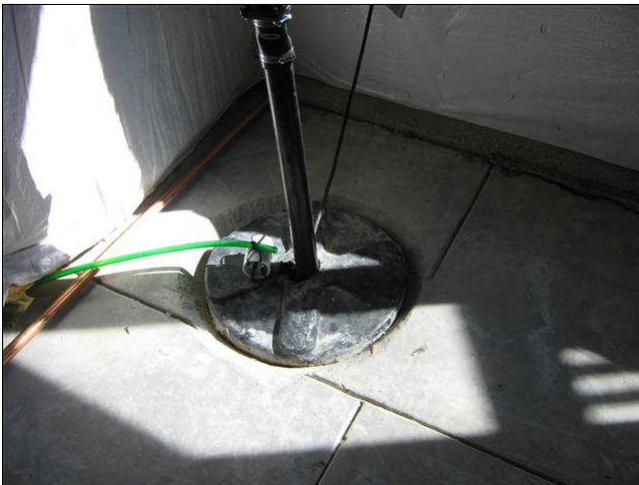
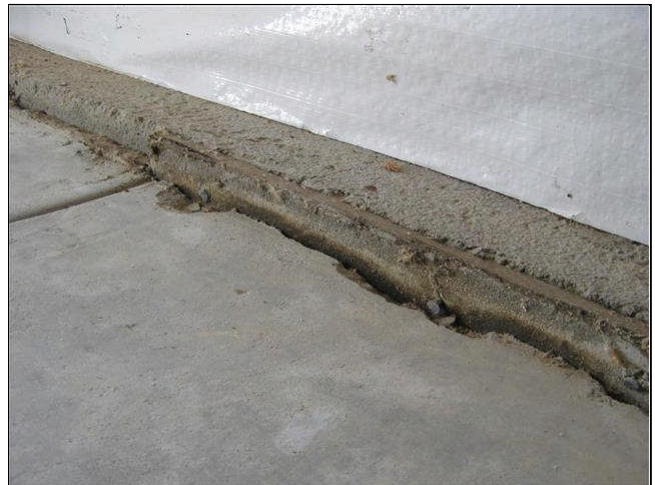
3.3 Item 1(Picture)

Moderate settling of the basement slab around the sump pit. Consult a "mud jacking" company. They may be able to push it back into it's original position or they may just be able to help stabilize the slab.

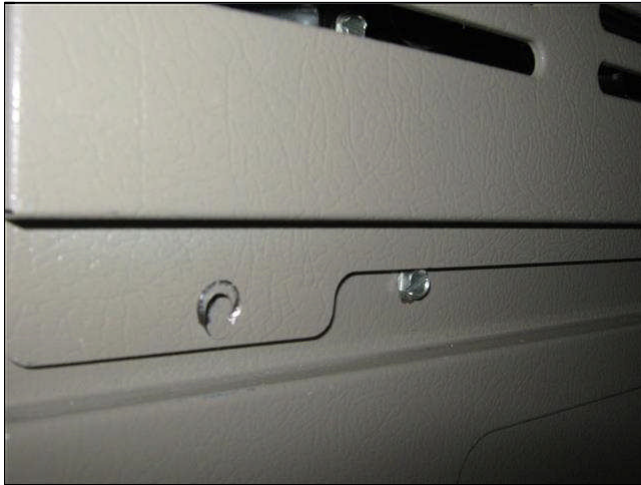
4.0 Item 1(Picture)

(1) There is a screw missing on the cover door for the furnace.

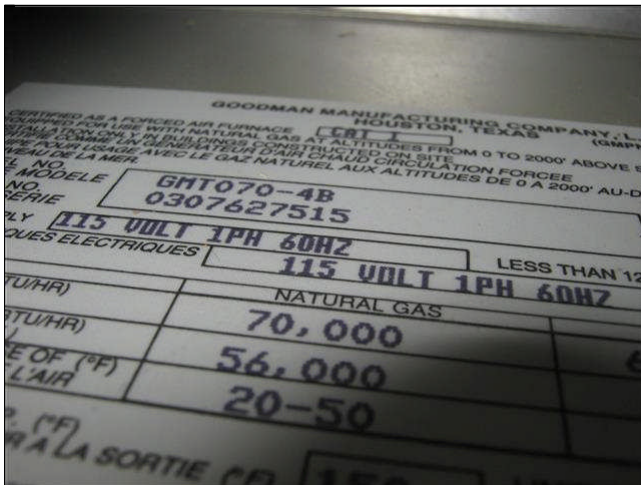
4.0 Item 2(Picture)

(2) The furnace is in good condition. It is clean, and has a filter installed. It appears to be well maintained. It is still recommended that you have a professional service the unit each year before the cold season begins.

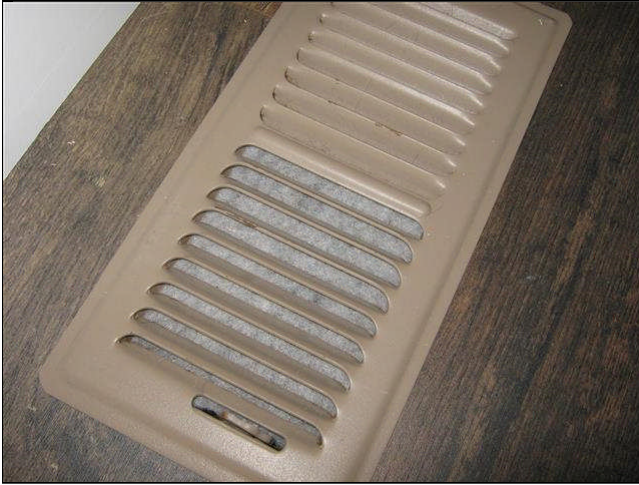
4.3 Item 1(Picture)

There is a filter in most of the registers. This is impeding air flow which could shorten the life span of the furnace. I recommend removing them.

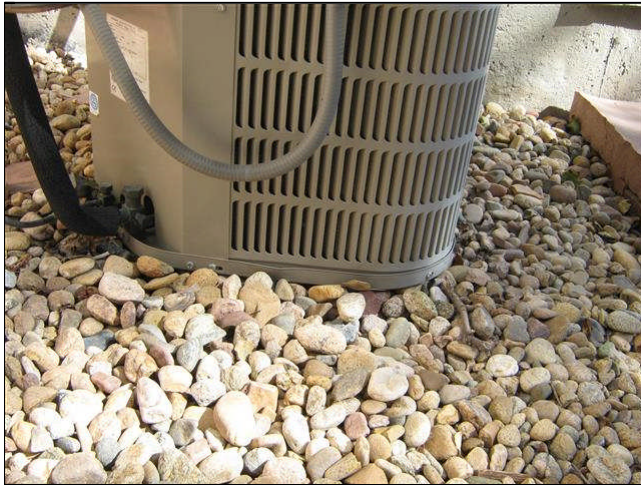
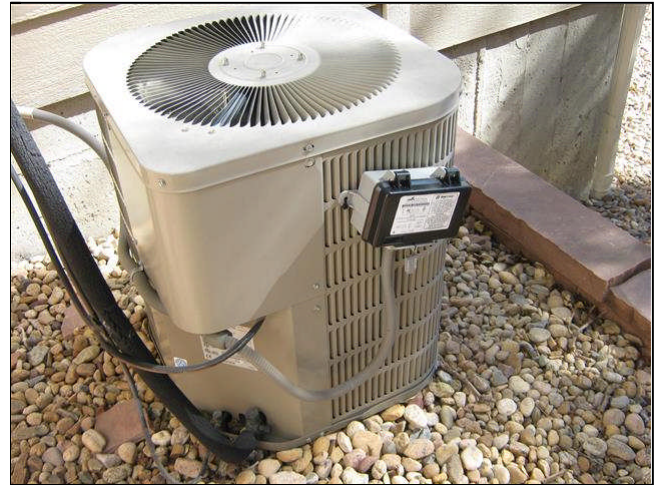
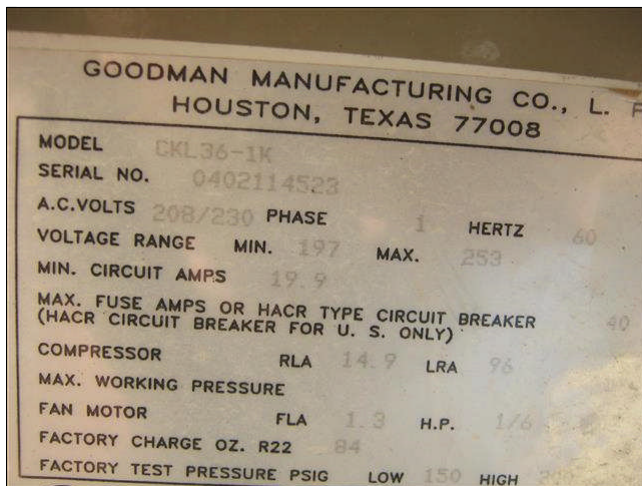
4.6 Item 1(Picture)

AC compressor is not on a concrete pad. Compressor needs to have a level concrete pad installed.

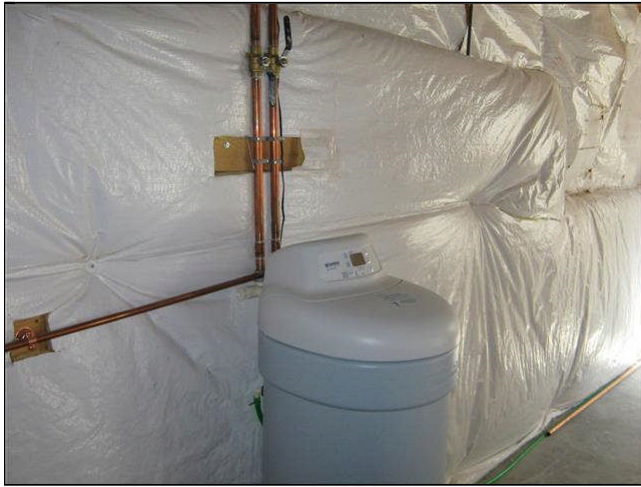
5.3 Item 1(Picture)

There is a water softener in the basement. I recommend consulting a water softener expert and having the unit serviced.

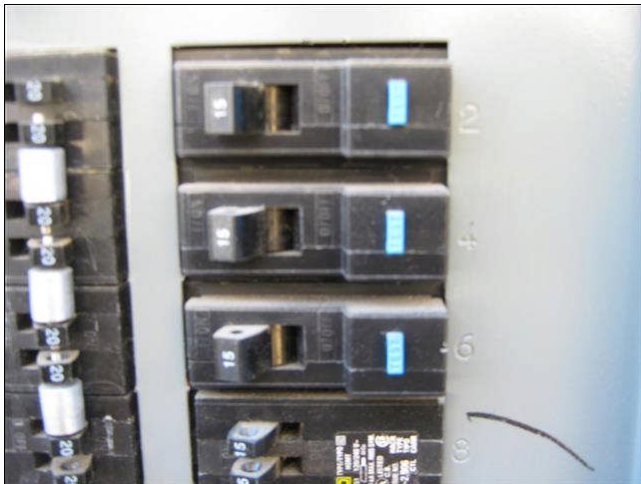
6.3 Item 1(Picture)

SAFETY HAZARD: The panel has 3 Square D manufactured AFCI breakers. Square D AFCI circuit breakers manufactured between March 1, 2004 and September 23, 2004 (Square D AFCI's with blue buttons) have been recalled. A licensed electrician is needed to check the date codes on these breakers to determine if they are subject to the recall. Consult a licensed electrician and replace if necessary.

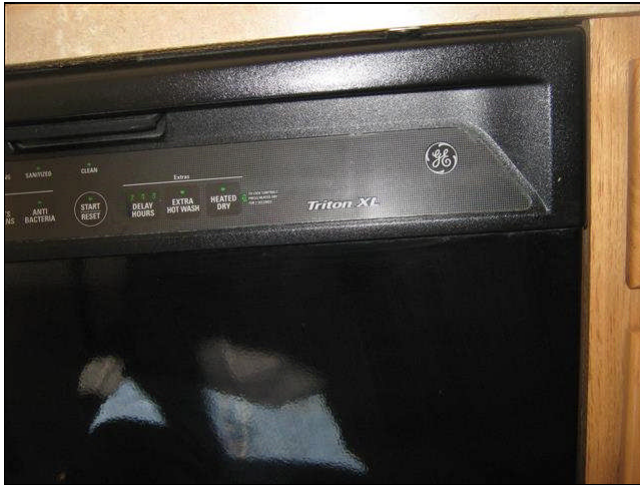
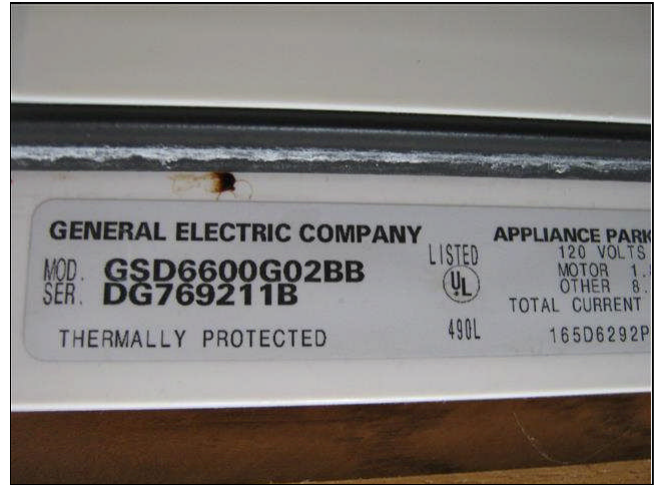
11.0 Item 1(Picture)

- (1) Dishwasher is very noisy. It may need to be replaced soon.
- (2) Dishwasher manufactured by GE in 2004, according to online source (Appliance 411).
